CH-54, CH-54A

CH-54
Marshall Hall
Marshall Hall Road (MD 227)
Bryans Road
Federal

NATIONAL REGISTER OF HISTORIC PLACES
INVENTORY -- NOMINATION FORMSEE INSTRUCTIONS IN HOW TO COMPLETE NATIONAL REGISTER FORMS
TYPE ALL ENTRIES -- COMPLETE APPLICABLE SECTIONS**1 NAME**

MARSHALL HALL

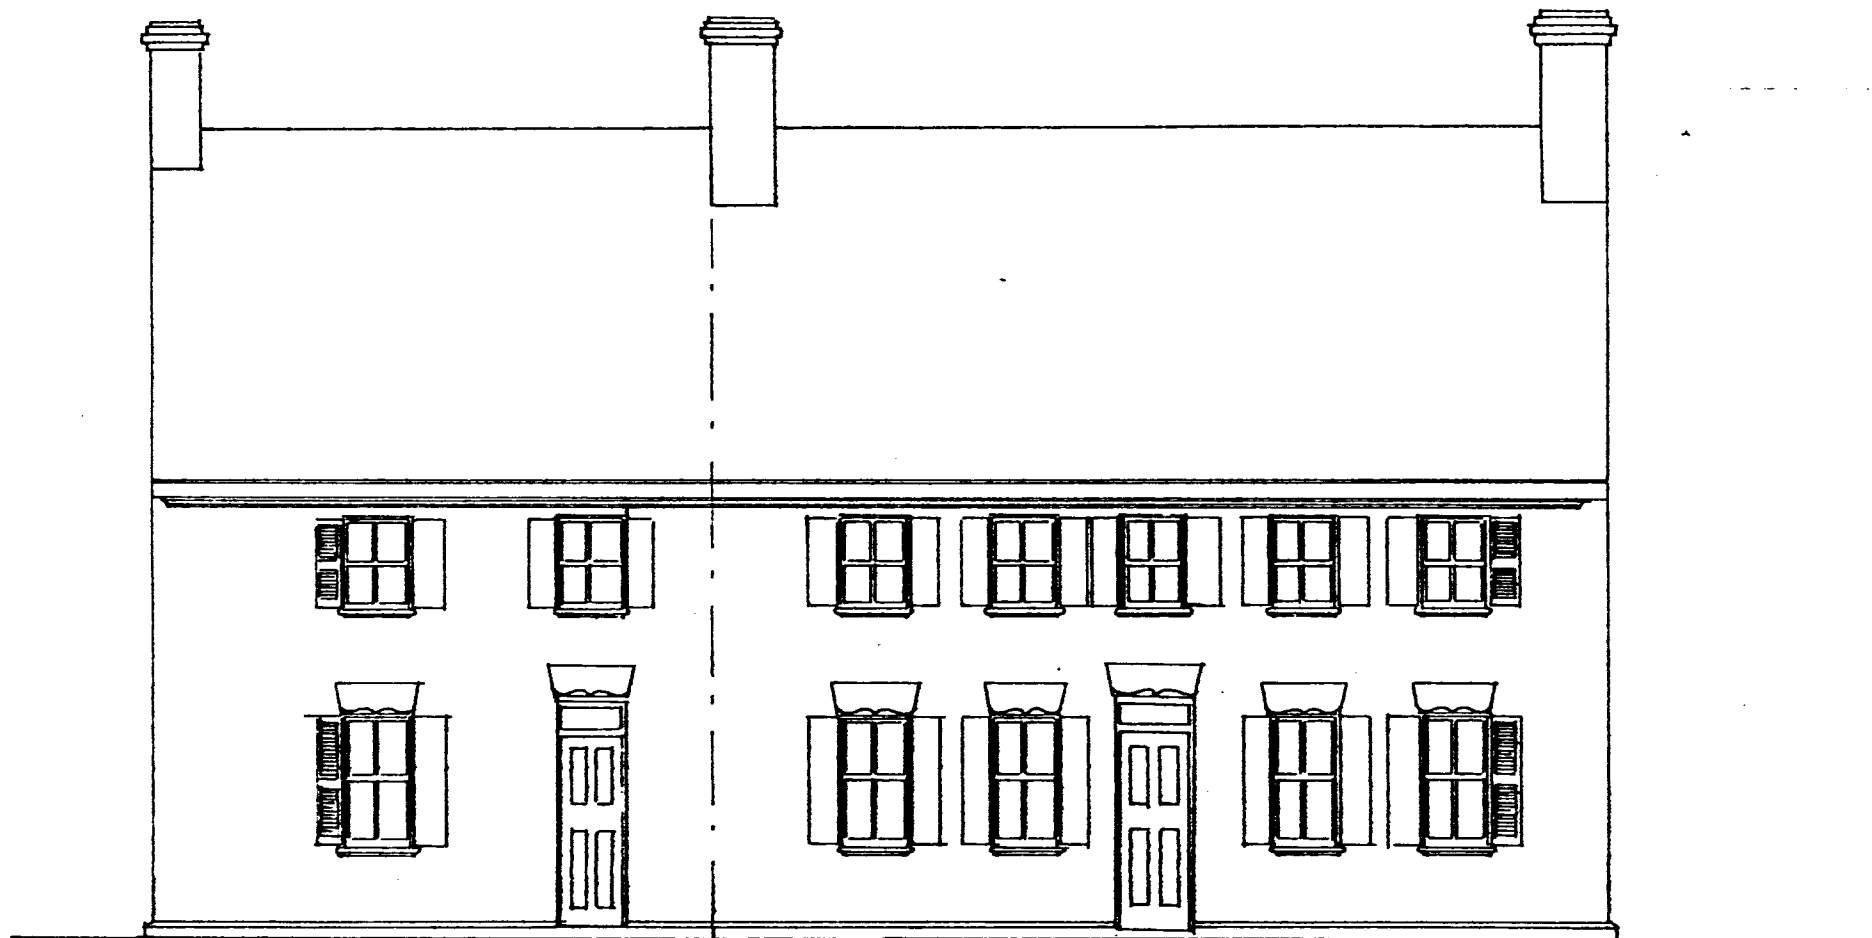
• Marshall Hall 'Mansion'
North Elevation, Front
scale : $\frac{3}{8}$ in. = 1 ft

The river front (north facade) of the 60 X 30 foot house is seven bays in length (see Figure 1). The first five bays from the west end constitute the original house of circa 1725; the two easternmost bays date from an extension of the house made in about 1760. On the first floor the original five bays consist of a center door flanked by two windows on each side. These windows and the door have splayed brick arches of rubbed and gauged brick, the bases of which are molded in a double-ogee pattern creating a highly decorative effect.² The five similarly spaced windows above have flat unornamented heads that are flush with the base of the roof cornice. All the windows have sash of two-over-two panes that are of Victorian vintage, although the windows themselves occupy the original locations. The doorway frames a modern door and transom and is now slightly narrower than it was originally.

The two first and second floor bays of the addition (a window and a door on the first floor and two windows above) also occupy the original locations and have two-over-two Victorian sash. The doorway frames a modern door and transom; the original width, however, is retained. An interesting feature on this elevation of the addition is the manner in which the bases of the window and door heads of the first floor were crudely chiseled out in an attempt to repeat the decorated flat arches of the four windows and door of the original house.

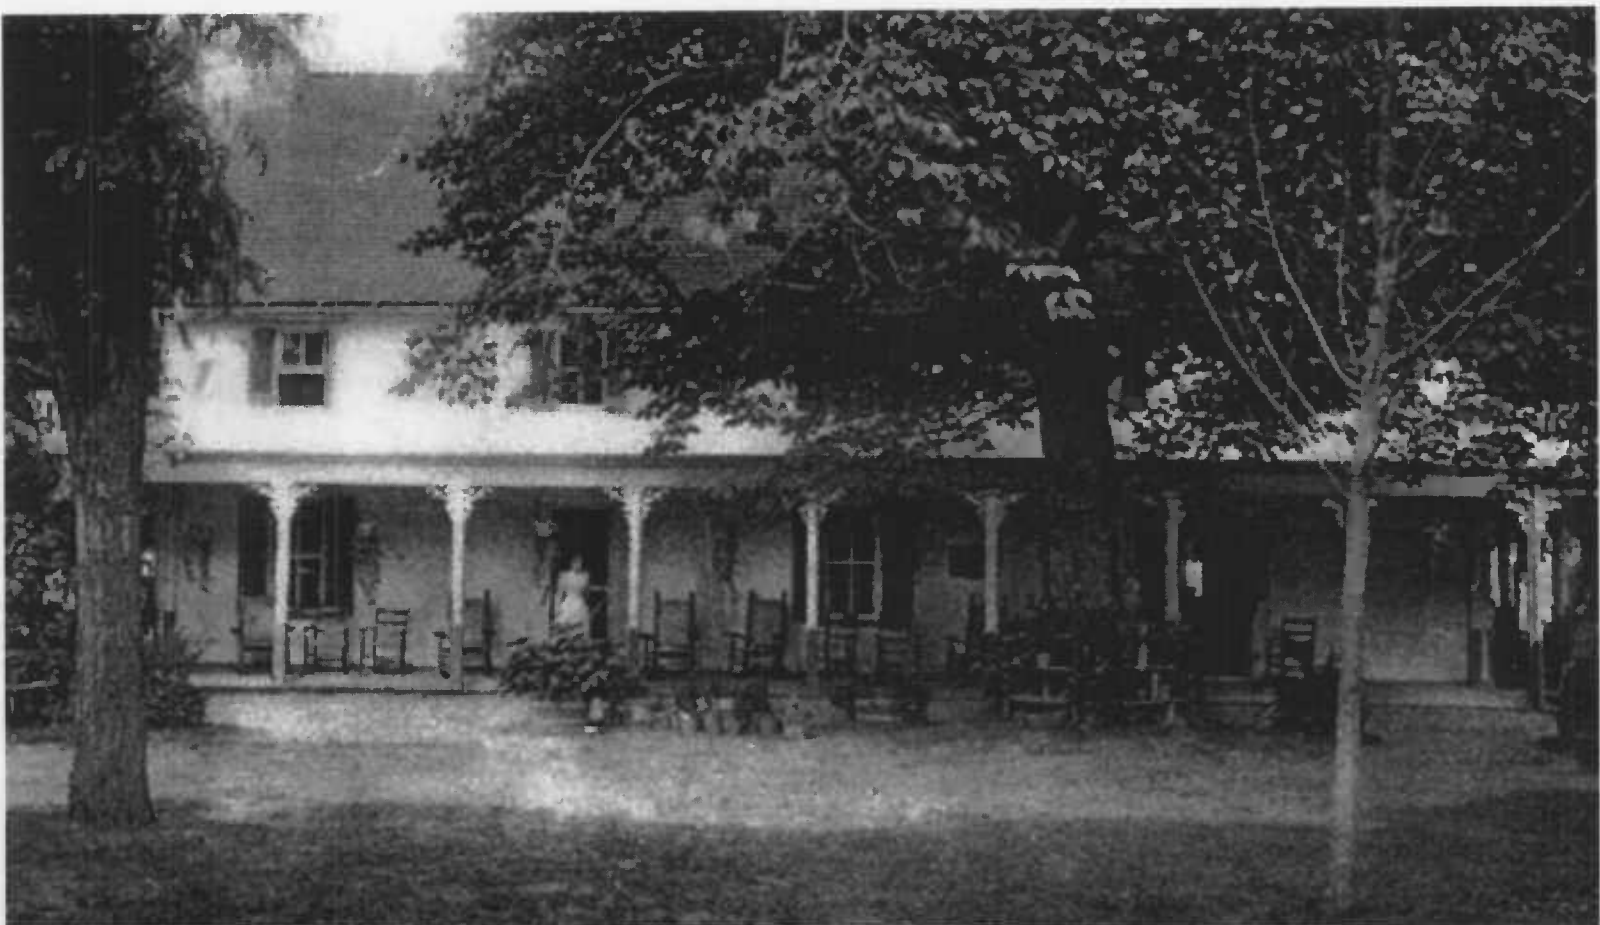
CH-54
Marshall Hall
c. 1900
South elevation

the older part, are unornamented and flush with the roof cornice. All windows on this elevation also held 2/2 Victorian sash. A photograph taken c. 1900 shows a Victorian porch with elaborate brackets spanning this entire elevation. Before renovation in 1966, the west gable end displayed a large flush chimney decorated on its outside face by an arched blind panel extending up from about the middle of the gable to just below the corbeled chimney cap. In 1966 the chimney stack was rebuilt above the gable peak, and though the panel was rebuilt, the arch was not. A closet window in this gable end was bricked up at an unknown date, as were two window openings on the east end of the house. Two windows pierce the second floor of the west gable end. The roof of the building flared at the eaves. Photographs from the 1950s and 60s show a modillioned cornice with ogee crown and bed moldings decorating the front and rear elevations, but this was removed in 1966. The basic interior plan was retained, along with a substantial amount of interior fabric. In 1976, the National Park Service bought the property, and planned to restore the building. On October 17, 1981 the house was completely gutted by an arson fire, leaving only the brick walls standing. The 60' x 30' walls were stabilized and fenced off until the building suffered yet another accident on January 12, 2003, when a large truck drove straight through the center of the building and out the other side. The bays destroyed on the south facade were the entrance bay and the bay to its east, and on the north facade, the entrance bay and the two to its east. Effectively, the central third of the building was completely destroyed.

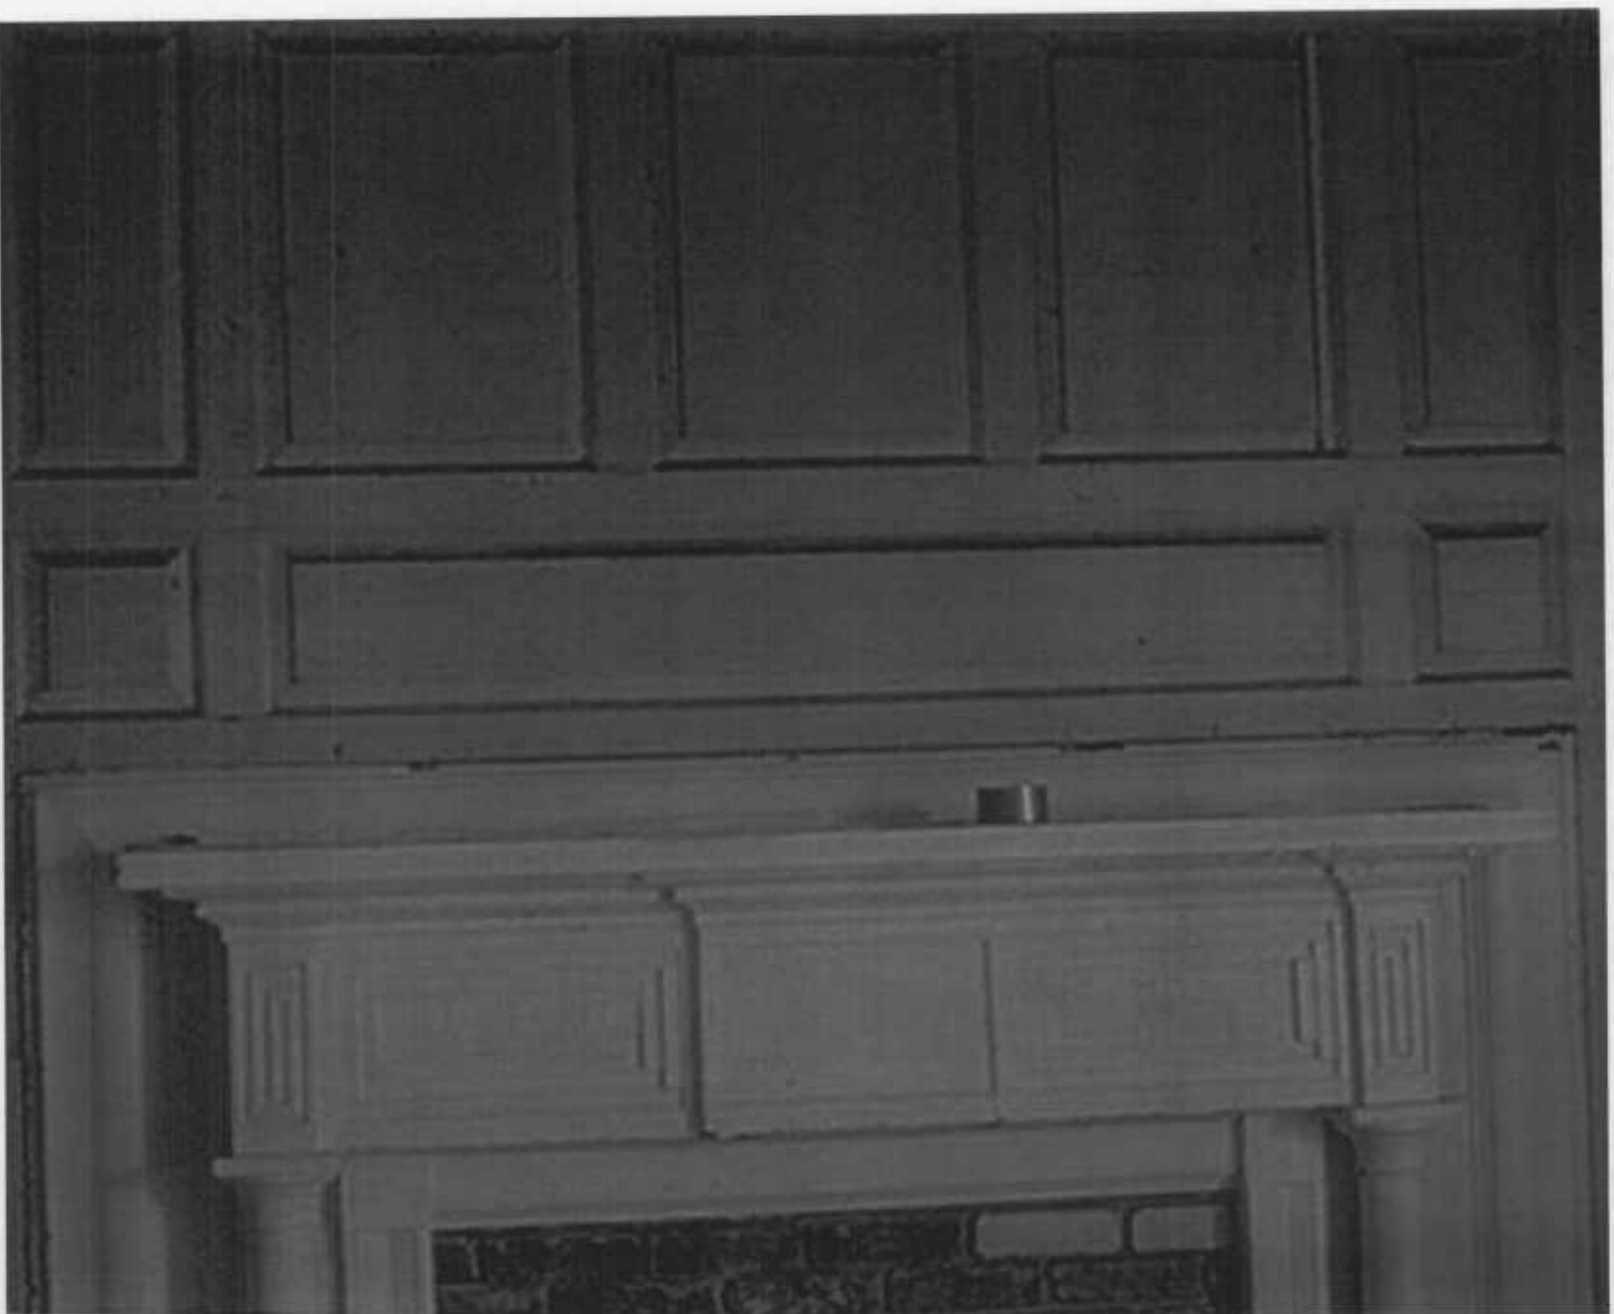
CH-54
Marshall Hall
Interior paneling
c. 1980

In the slightly smaller northeast room, the walls were decorated with paneled wainscoting, baseboards, chairrails and ceiling cornices. All of this woodwork, however, has been removed and its current whereabouts remain unknown. The wall areas above the wainscoting and the ceiling were plastered, first painted and then papered. The fireplace in this room has been completely covered, but the measurements of the chimney base indicate that it was about the same size as that in the northwest room. Flanking the fireplace in the northeast corner is a two-part cupboard with two sets of paneled doors. A door connecting the two front rooms was covered during the 1966 renovations.

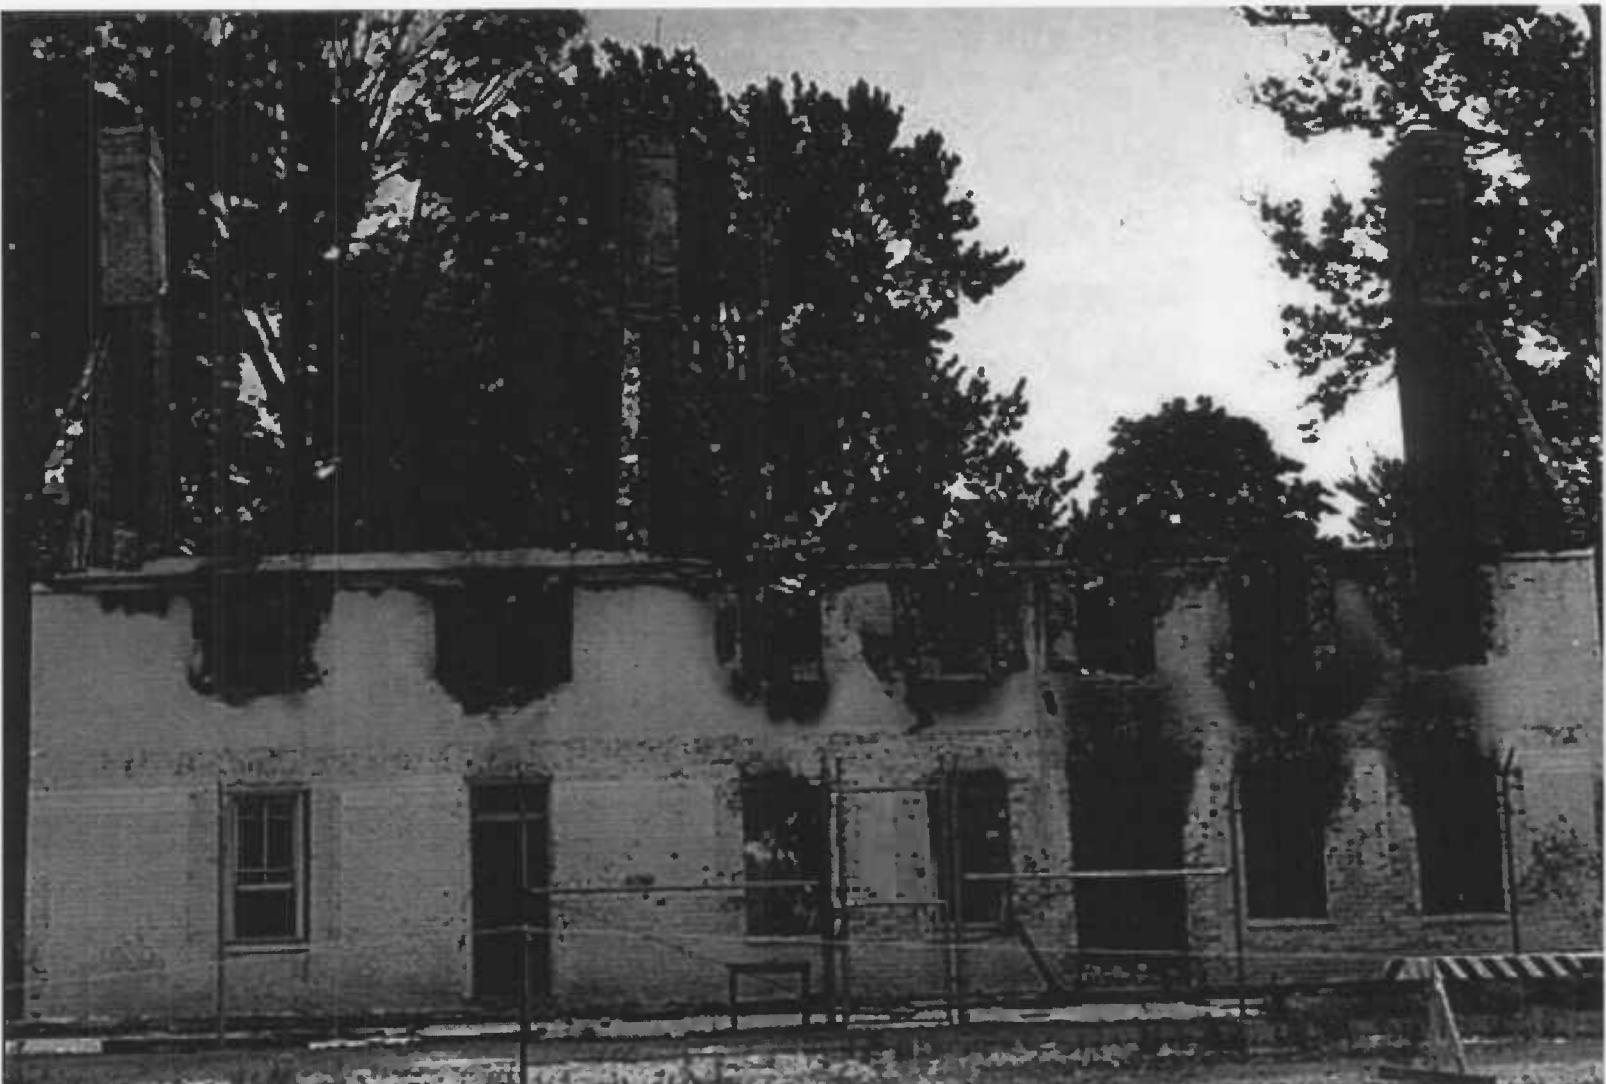
CH-54
Marshall Hall
October, 1981
North elevation

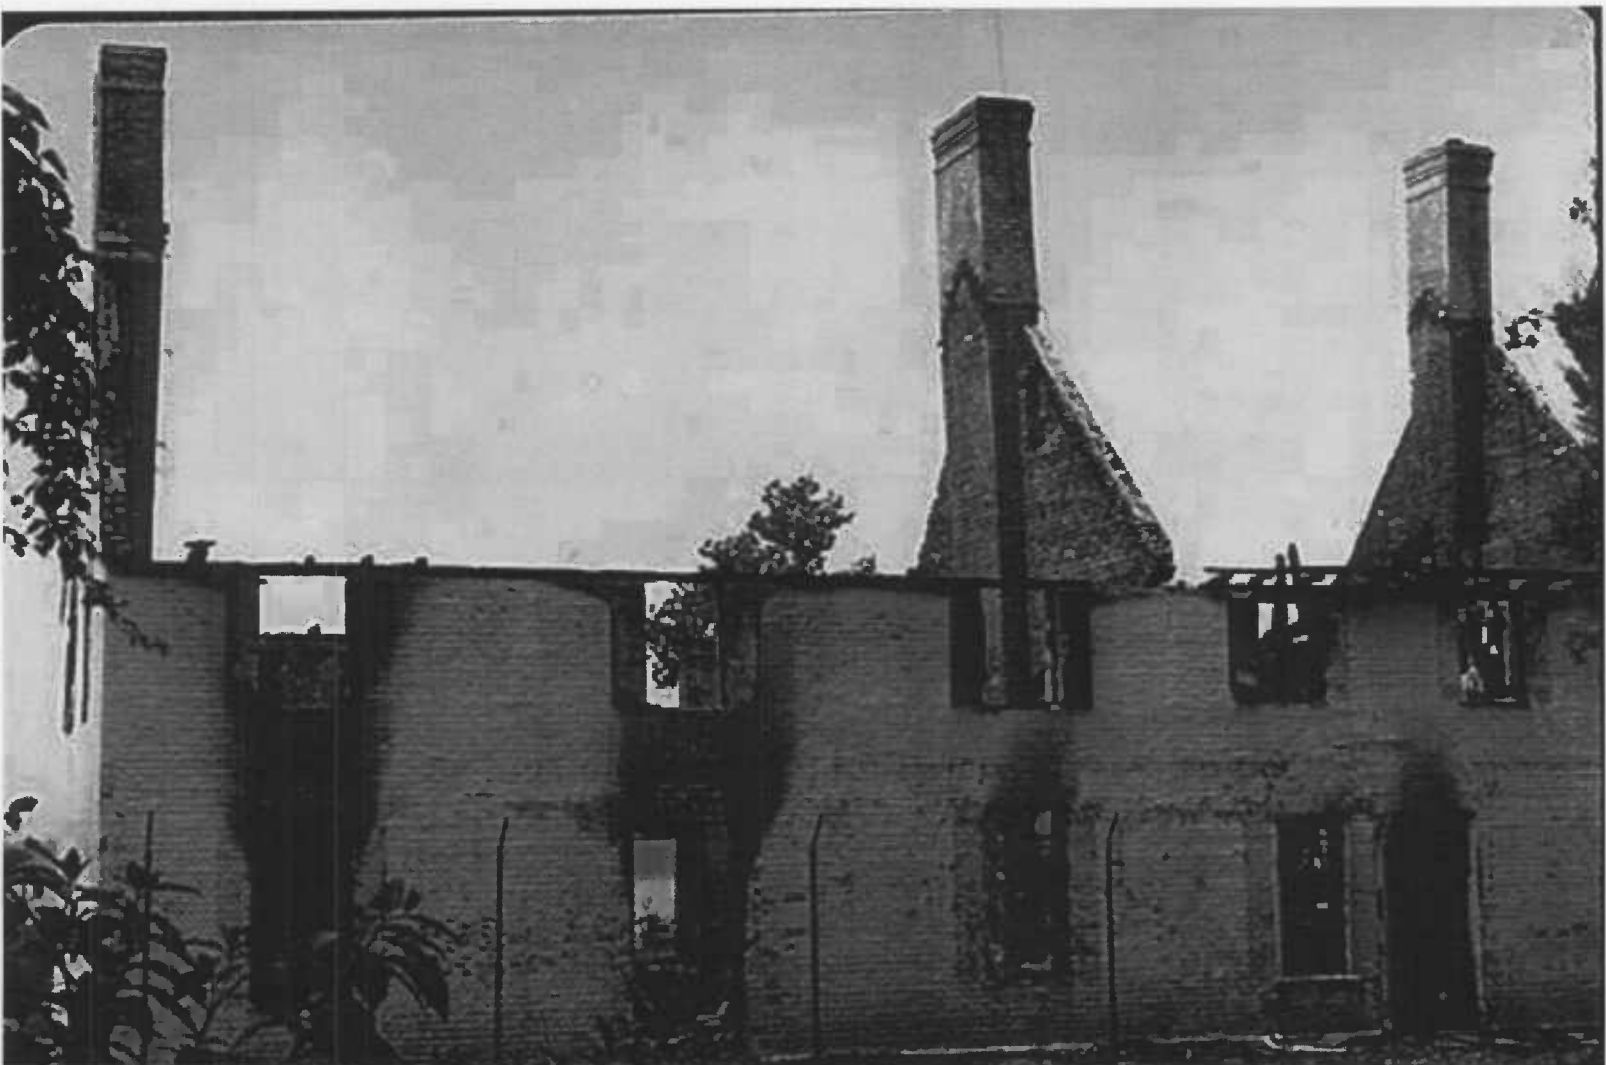
CH-54
Marshall Hall
October, 1981
South elevation
